# UltraBaseSystems™

Solving Synthetic Turf Installation Problems  
One Panel at a Time

Geotextile Stability Study - October 05, 2011

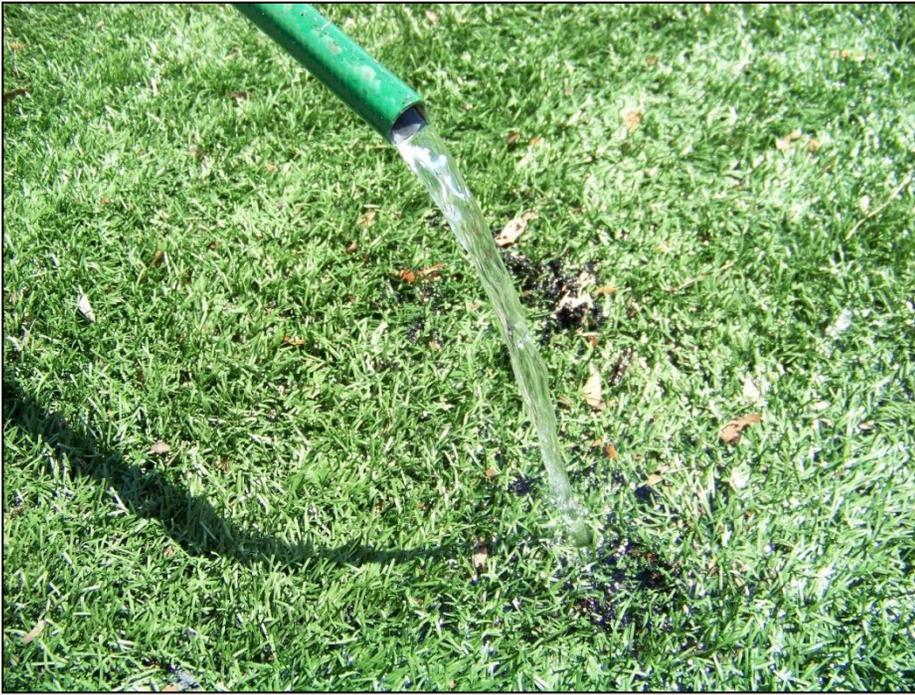
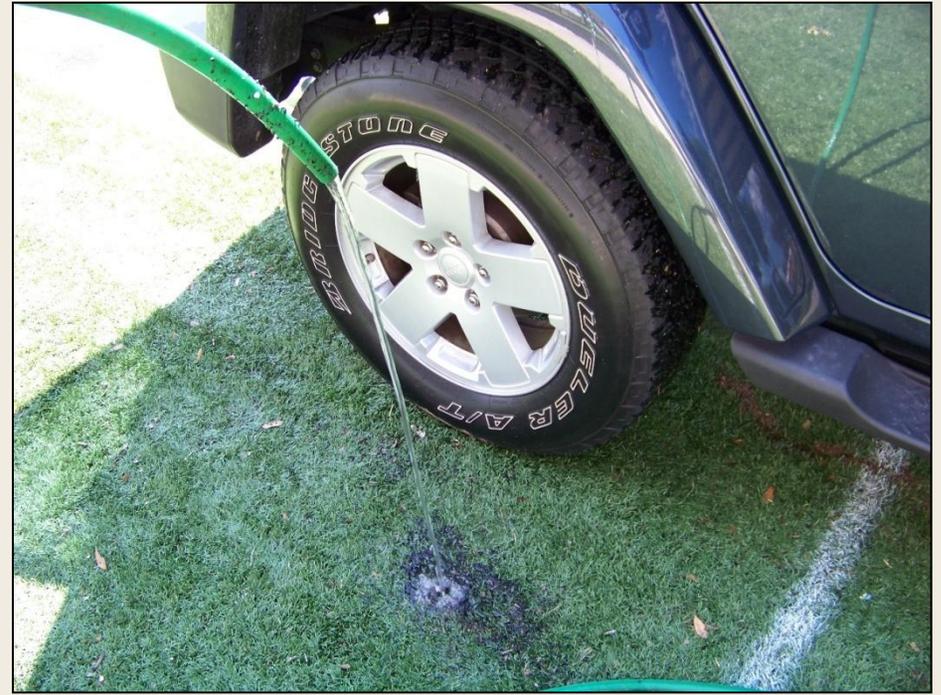
Our test site in Florida was the location to see the effects of extreme load on saturated ground that was covered by UltraBaseSystems™ panels and turf. The area is nearly 3 years old so it was a perfect test zone

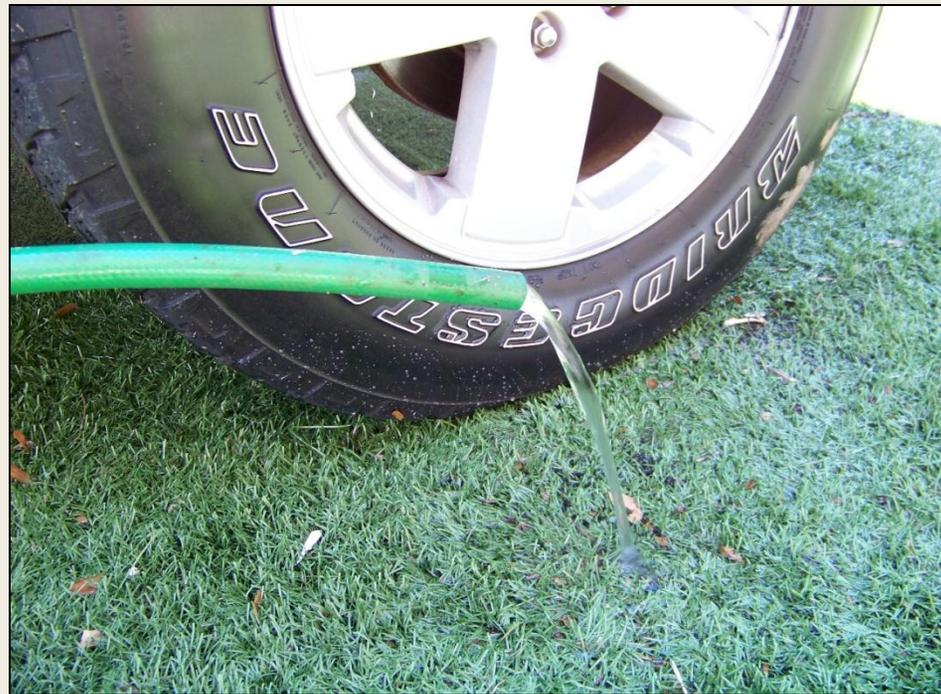
Water was allowed to run through the turf and panels and into the compacted earth below for nearly an hour. The area chosen was approximately one interior panel of a 2000 sq ft area

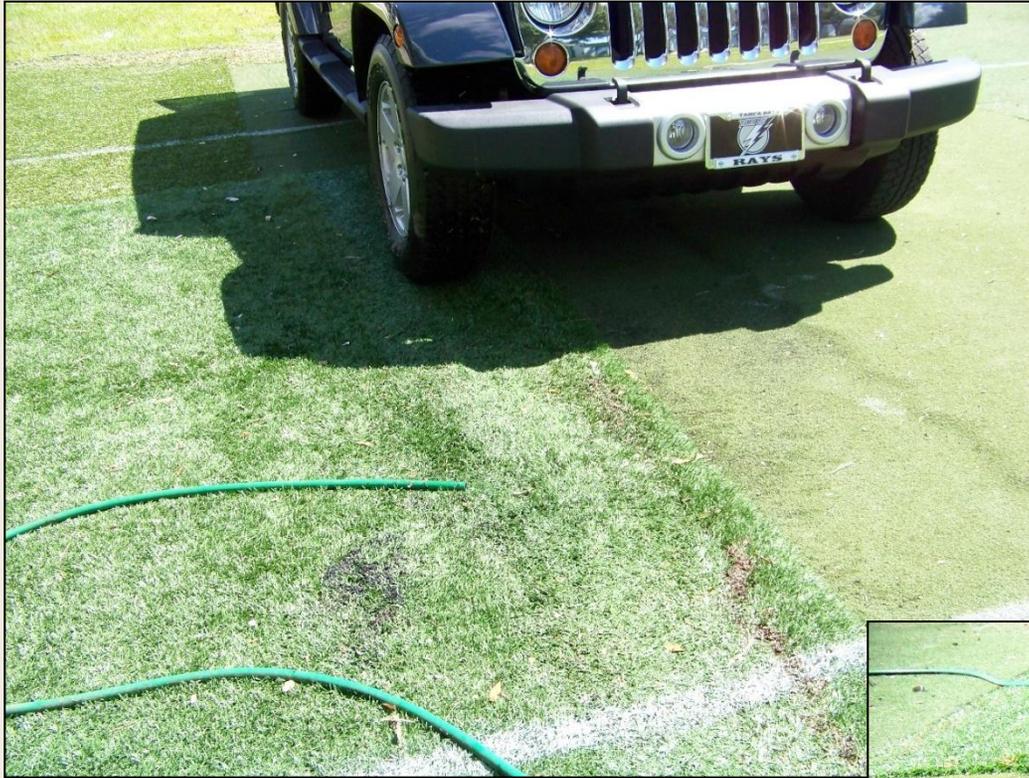
We drove repeatedly back and forth across the saturated turf area for over 50 cycles.

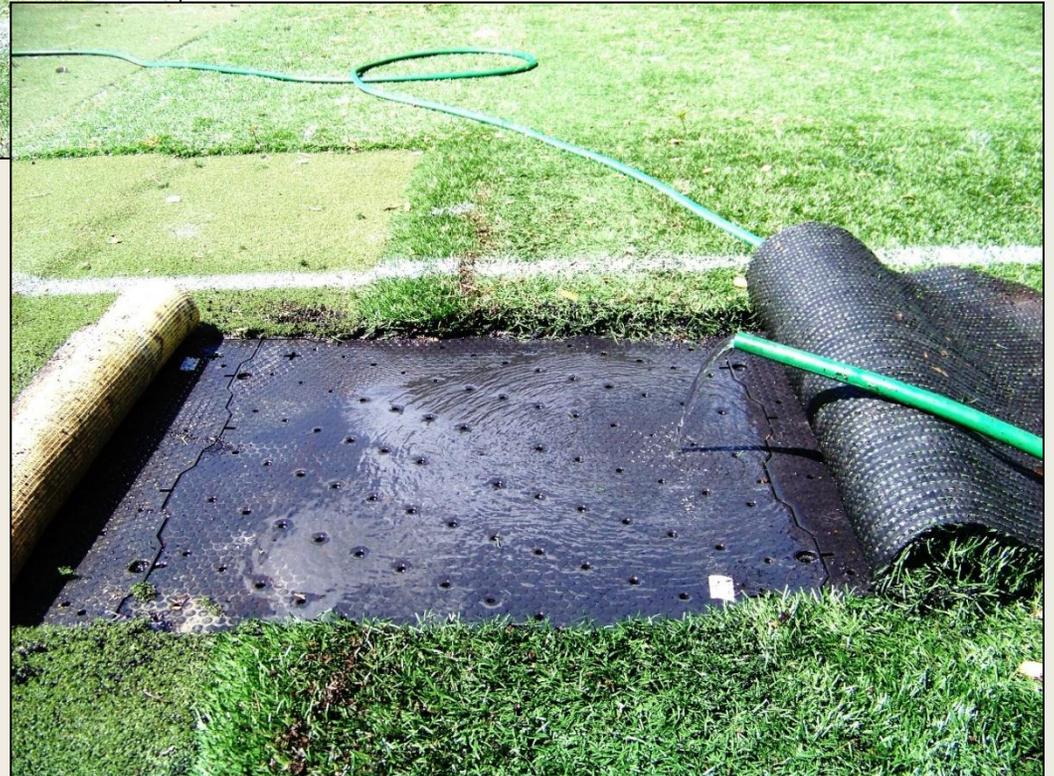
The turf was then removed and water was concentrated directly onto the panels for fast drainage to the geotextile and earth below.

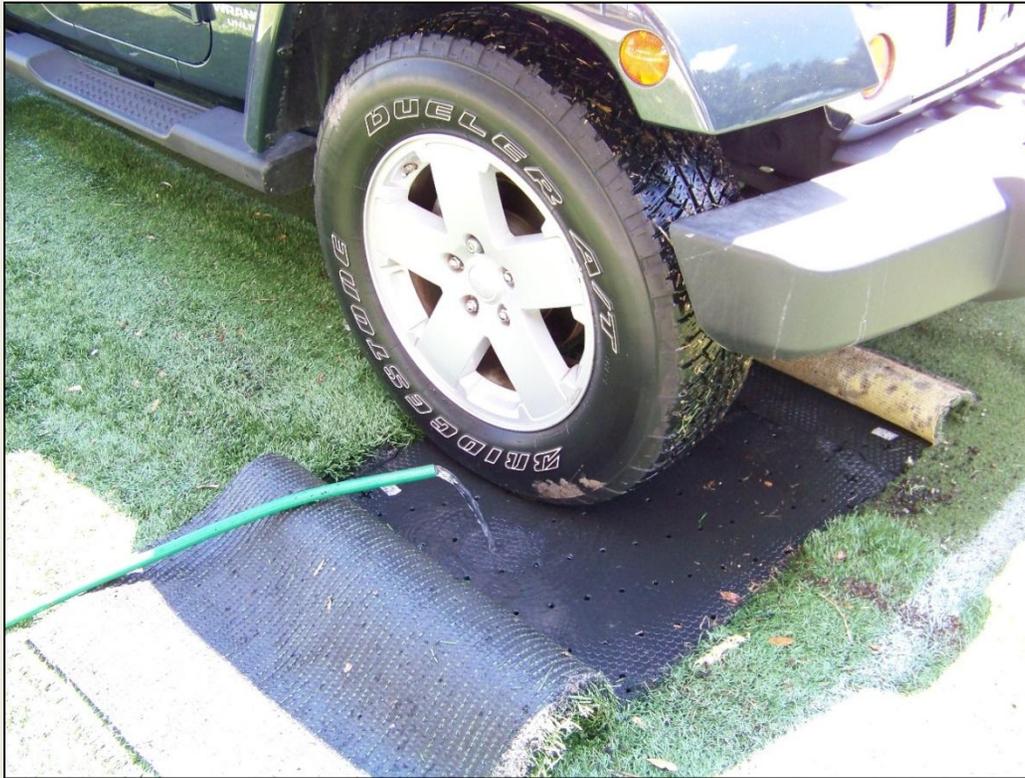
We once again drove back and forth over the exposed panel.

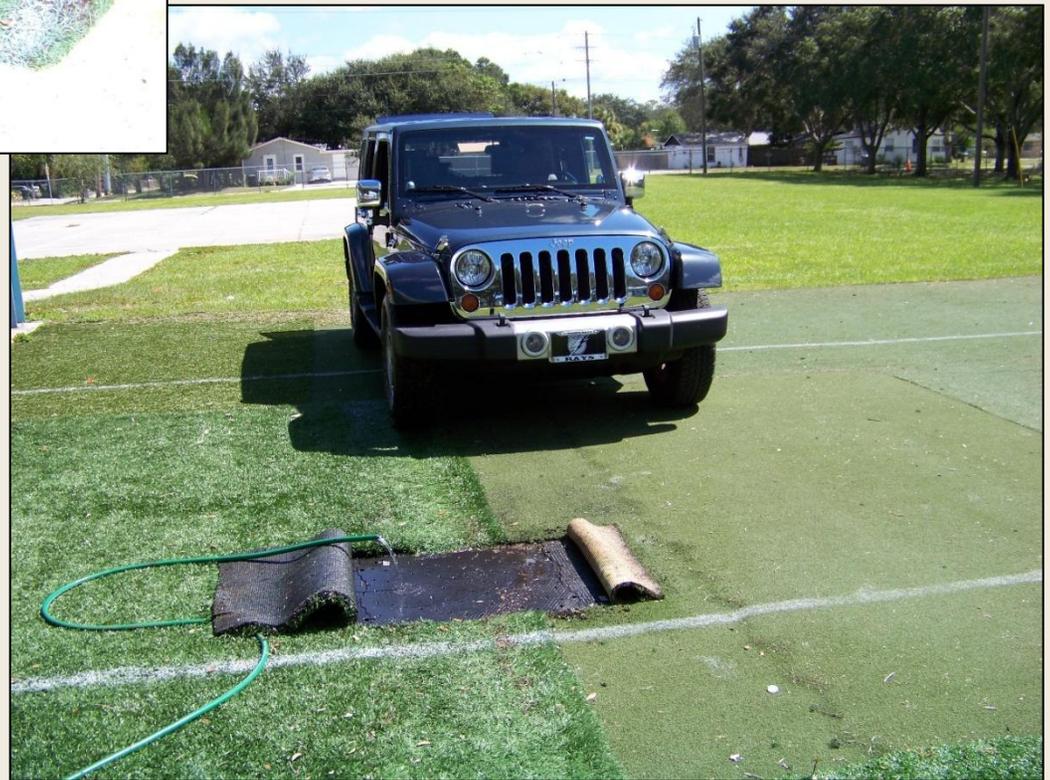
There was no evidence of any deformation or decreased stability of the panel after the car was removed.

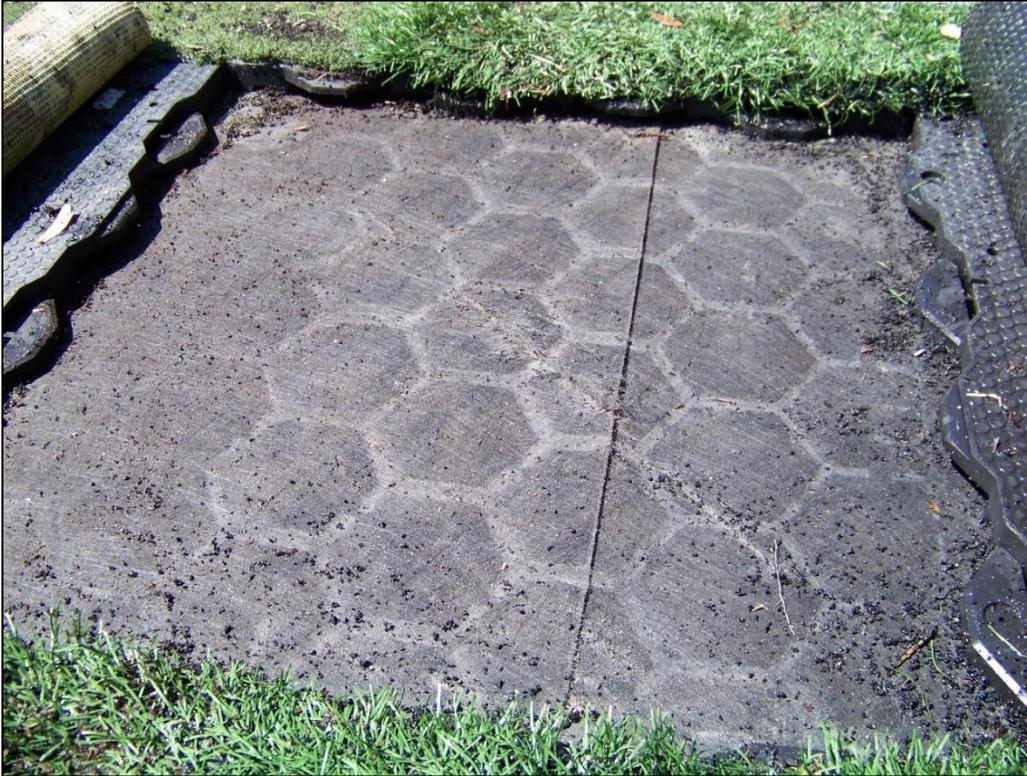
We carefully cut away the panel trying to be sure not to disturb the geotextile material.

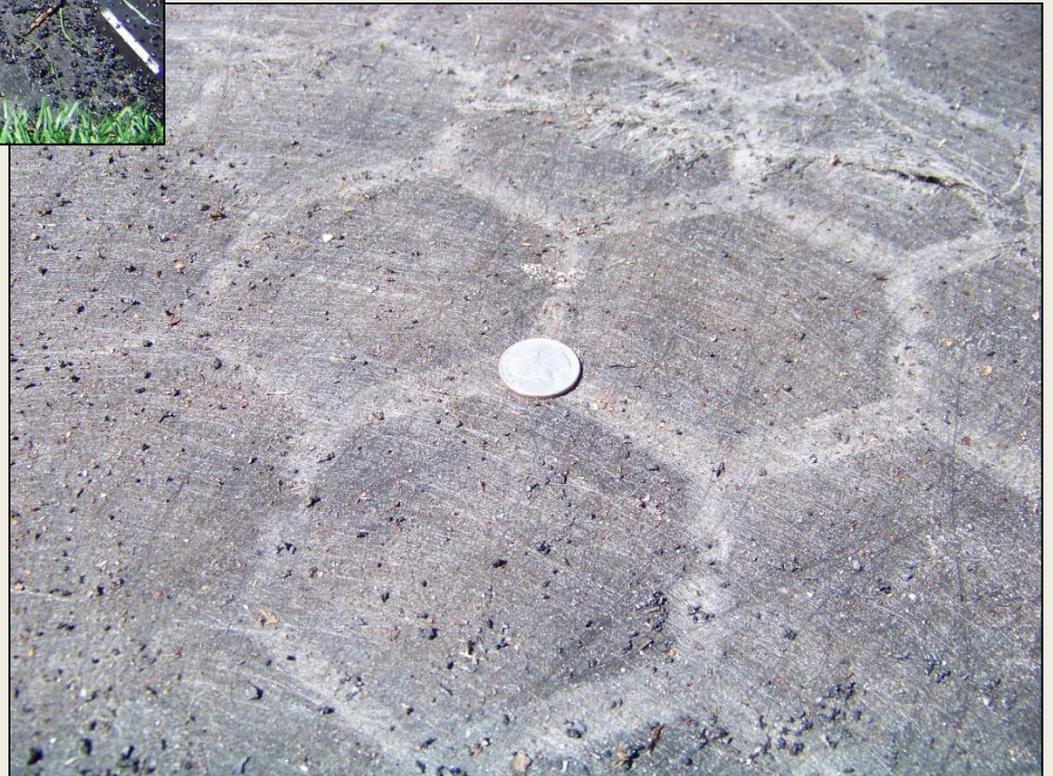
The exposed geotextile material showed little sign of deformation of the earth below. In fact the indentations were less than the thickness of a quarter.

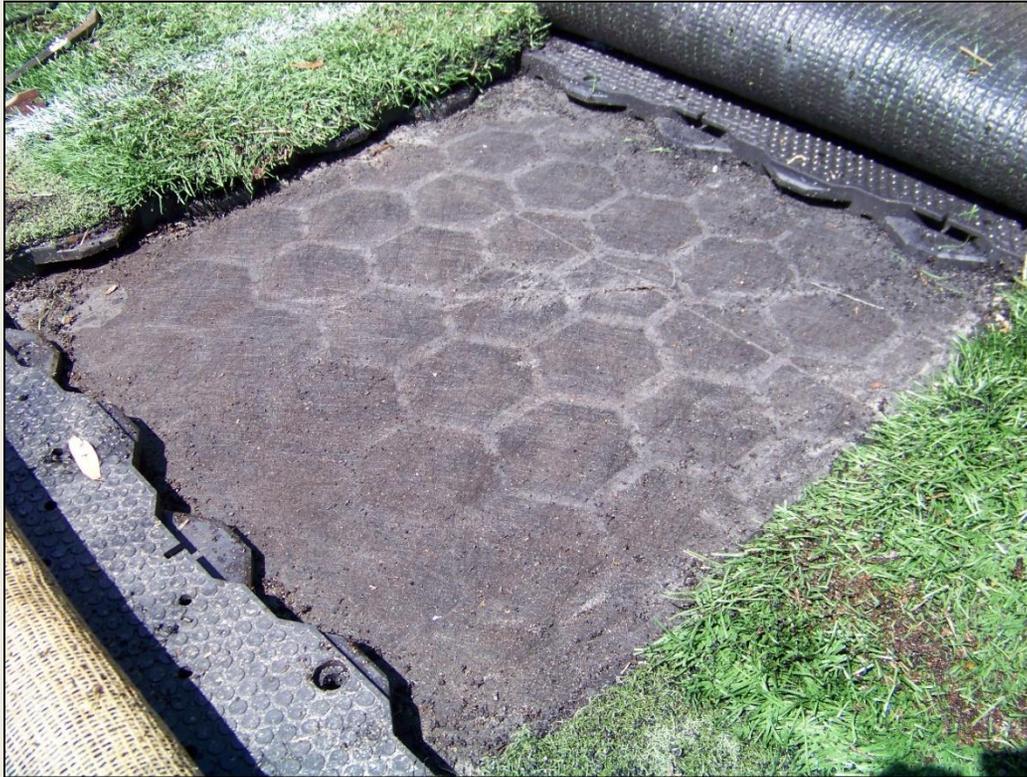
Another view of the virtually unaffected geotextile

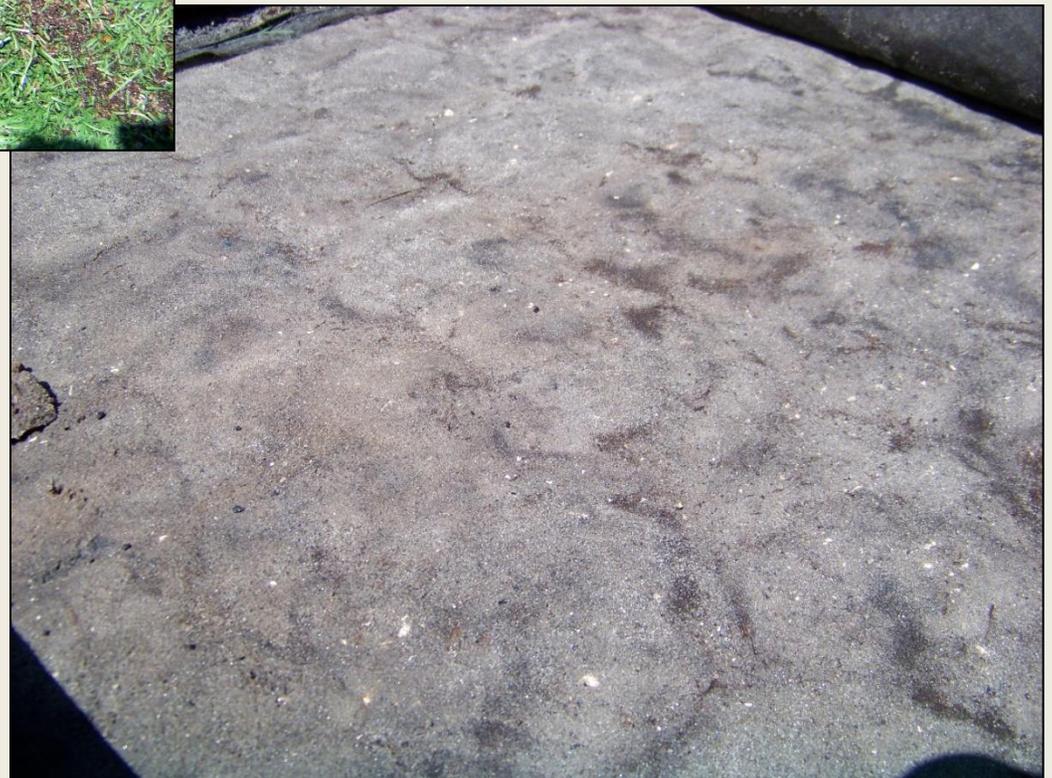
We removed the geotextile and could see the earth was very wet yet showed minimal deformation.

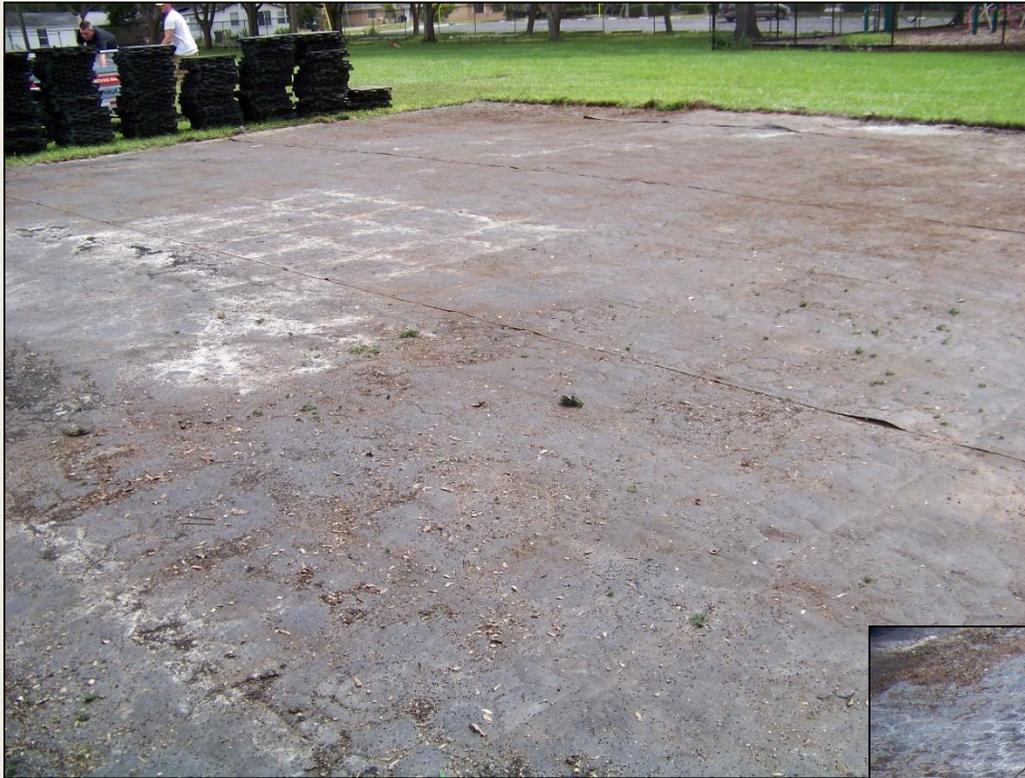
After 3 ½ years this valuable test site had served its purpose and was time to return the area back to natural grass. We removed all the panels and exposed the geotextile which showed little effects of the panels settling into the ground.

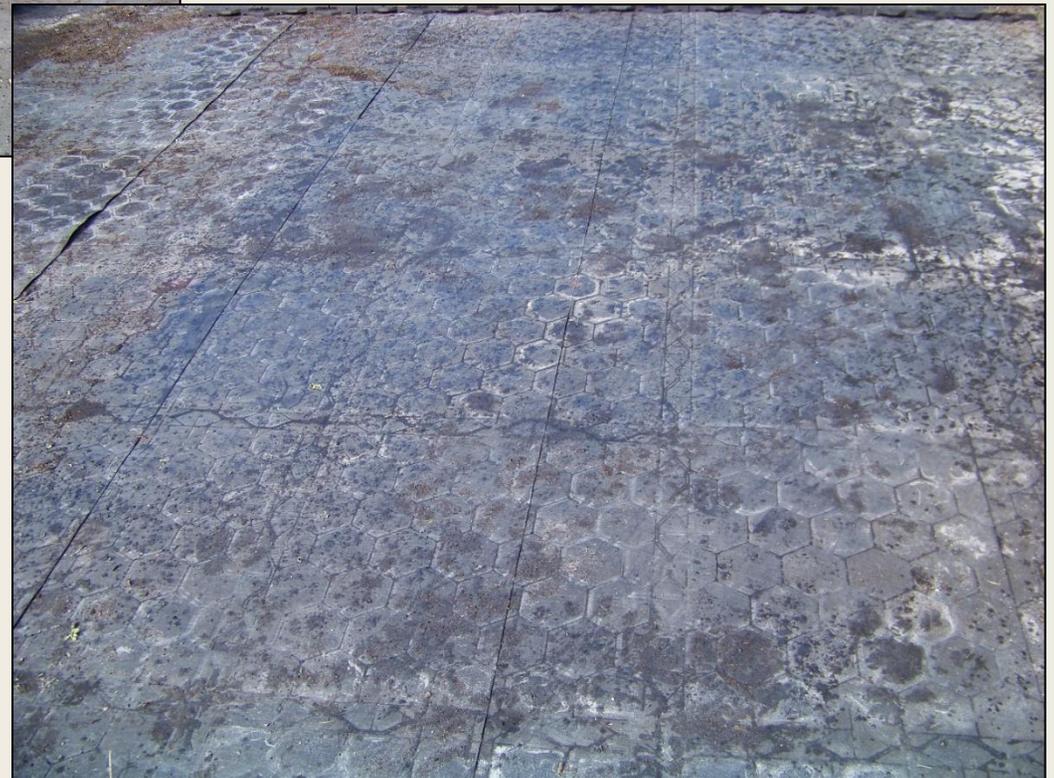
We have concluded that the heavier the geotextile face weight the better stability it gives to the panel installation. A face weight of 6 oz or more per square yard of our spun bond polyester geo is a great choice.

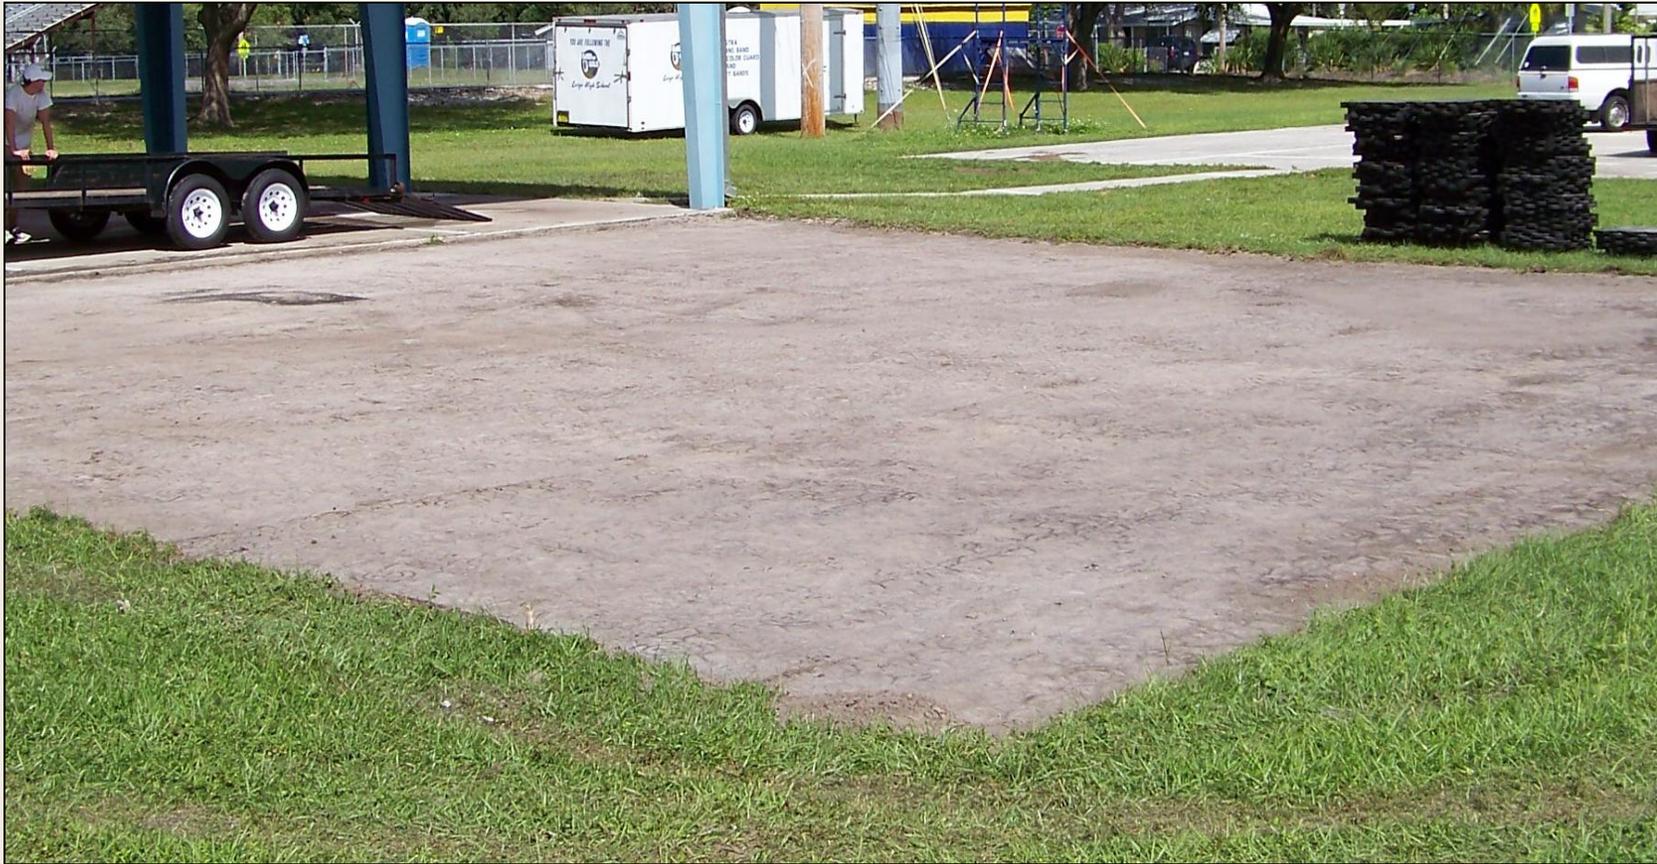
We removed the geotextile exposing the existing earth base. This is the area after removal.

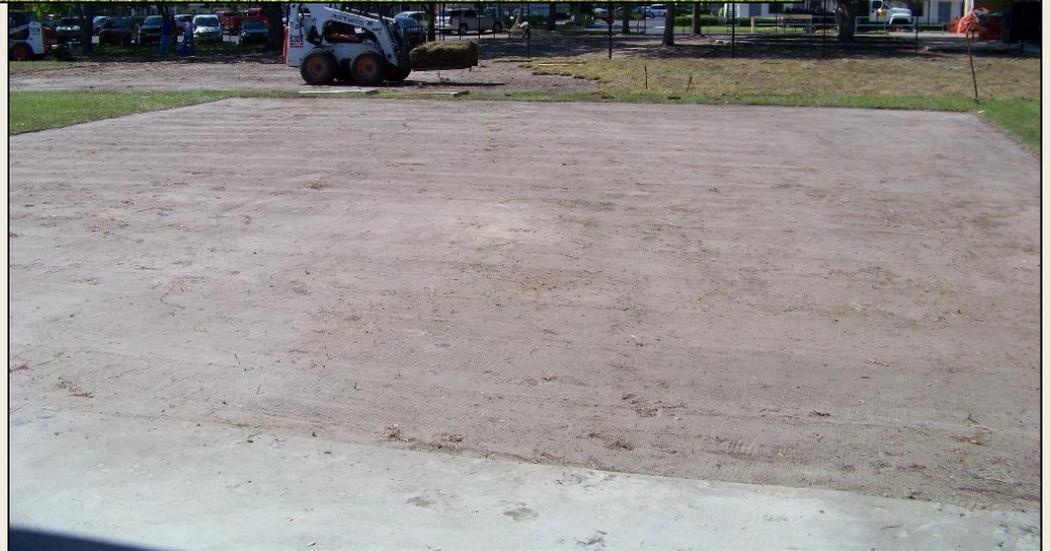
This is the area prior to installation. The before and after shots of the area show very little change over the last 3 ½ years
